# Hazard alert

**Urgent warning to licensed plumbers working on hot water systems**

## Serious risks associated with working on hot water systems connected to uncontrolled heat sources

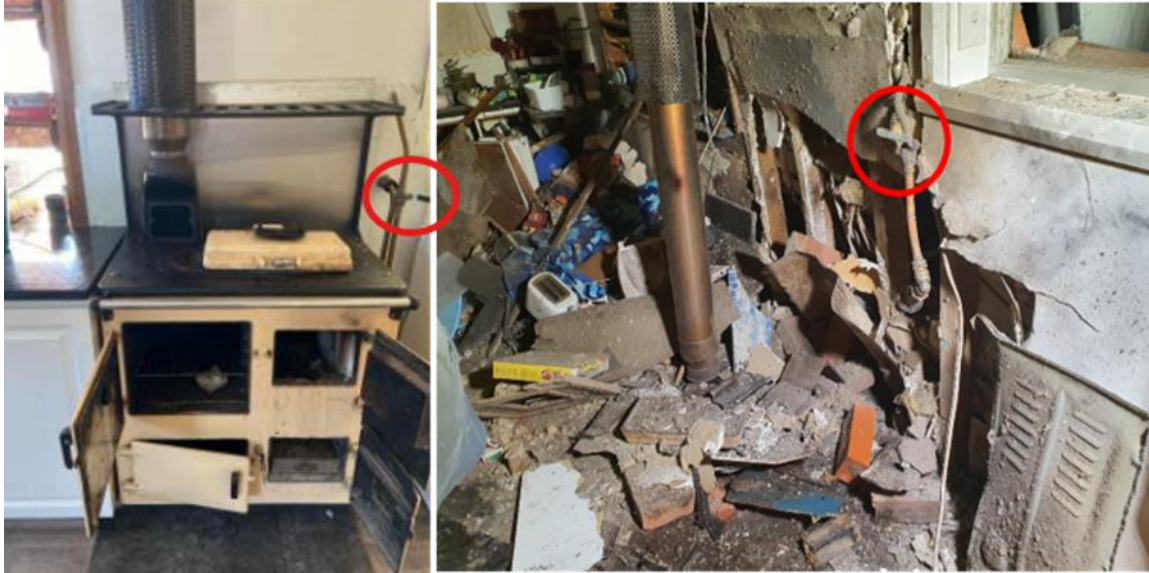
Before and after: A slow-combustion stove with wetback water jacket (note the isolation valve)

Flow and return pipework associated with an uncontrolled heat source must **never** have provision for being isolated or capped off. This requirement is clearly set out in section 7 of **AS/NZS 3500.4**.

Any modification that prevents the safe circulation of water through an uncontrolled heat source can create extremely dangerous pressure and temperature conditions.

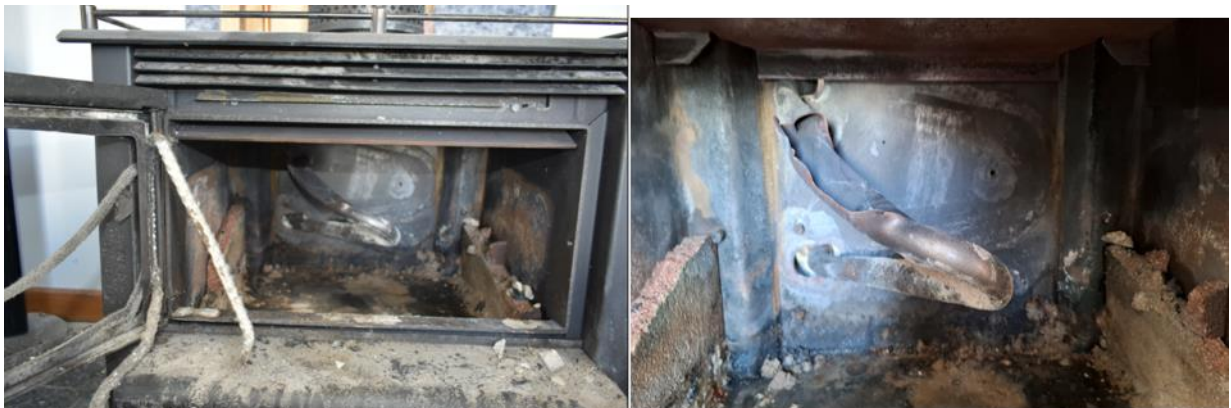
A capped off flow and return from a water jacket in a wood heater that has exploded; causing serious injury

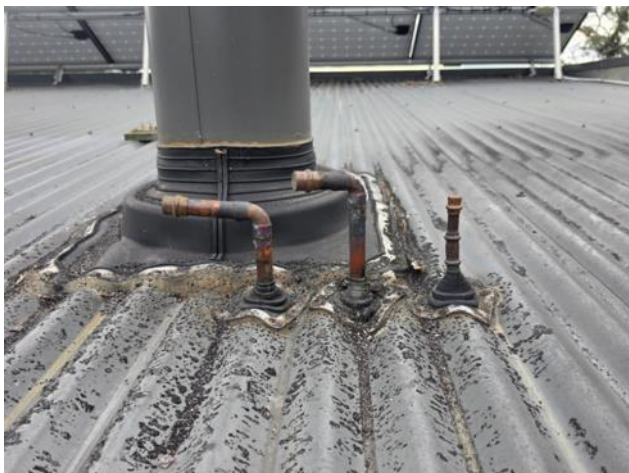
Sealed off flow and return pipework

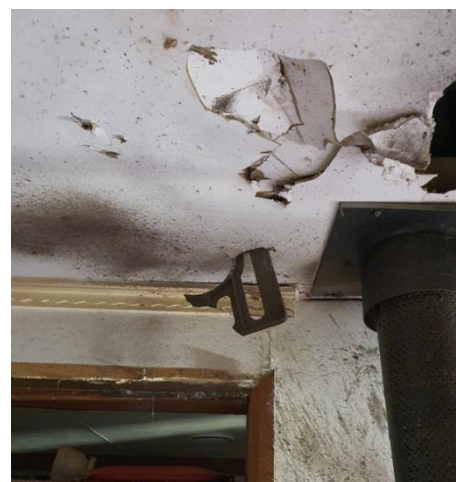
A large fragment of cast iron lodged in a ceiling
